# Doubly Reinforcing Cementitious Beams with Instrumented Hollow Carbon Fiber Tendons

**Abstract** Surface mounted strain gages are used to characterize the behavior of polymer-enhanced cementitious beams designed to withstand reverse loadings. These unique composite structures are doubly reinforced with hollow carbon fiber (graphite) tendons equipped with strain gages and the study includes section design, materials considerations, structural testing, and finite element analysis. The primary purpose of strain gage integration is to insure that the stress in the materials remains within the elastic range so that damage does not occur. A finite element model is developed to characterize the structural response in the elastic range and a hybrid approach is suggested in which displacement, strain, and stress can be obtained with a single strain gage. The ability to characterize structural performance beyond the elastic range is also demonstrated by analyzing data obtained from displacement-controlled tests.

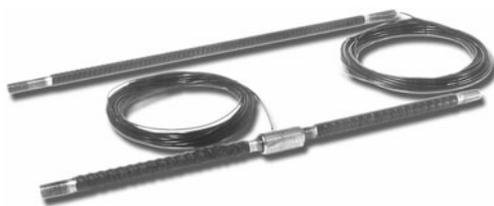
As illustrated in Fig. 1, strain gages have been installed within hollow steel rebar and sister bars [15]. The rebar is embedded directly into the matrix for structural purposes while the sister bar is installed by tying it alongside an existing length of rebar in the rebar cage. Several bars can be joined by screwing them together.

**Fig. 1** RocTest Telemac's instrumented rebar (top) and sister bar (bottom) [15]

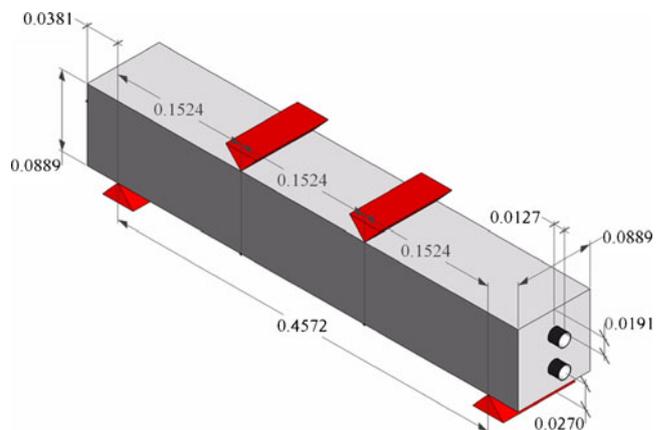
The height and width of the beam were 0.0889 m and the total length of the reinforced concrete section was 0.5334 m. This allowed a four point bend test to be conducted over a 0.4572 m long span comprised of three equally distant

**Fig. 2** Schematic diagram of the four point bend test (dimensions are in meters)

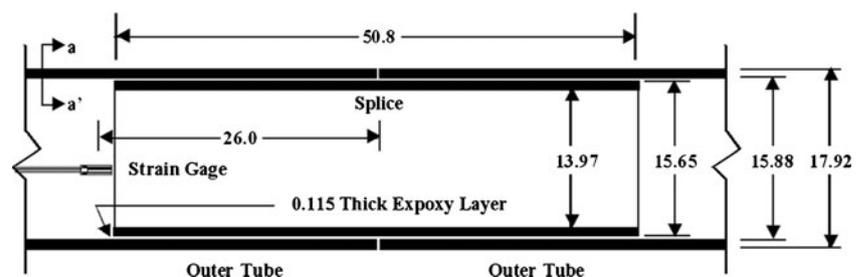
As illustrated in Fig. 3, each tendon consisted of two equal length sections of carbon fiber tubing which were spliced together at the center of the beam to facilitate strain gage placement. Each of the 17.92 mm diameter outer tubes had a wall thickness of 1.02 mm and an inner diameter of 15.88 mm. The 50.8 mm long, 15.65 mm diameter splice was constructed by machining down the outer surface of a different carbon fiber tube which had an inner diameter of 13.97 mm.

A pre-wired, uniaxial strain gage (Omega Type KFG-3-350-C1-11L3M3R) was placed in the longitudinal direction on the inner surface of one of the outer tubes before the splice was inserted and glued in place. The gage was located adjacent to the splice, at a distance of 26.0 mm from the center span of the beam and the lead wires from the gage were fed through the hollow tendon to a data acquisition system.

**Fig. 3** Central section of an instrumented tendon (dimensions in millimeters; see Fig. 5 for Section a-a')

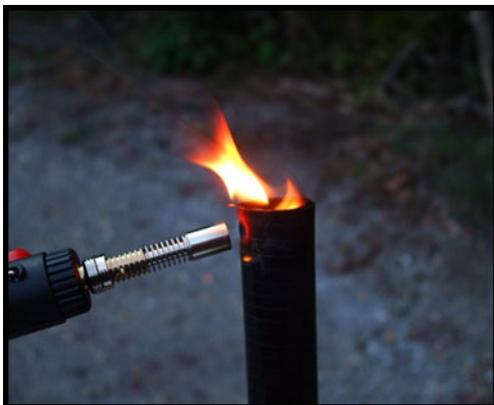
Figure 4 shows a photograph taken during the first step in this process where the outer tube was torched to determine the composition in its wall.

**Fig. 4** The outer tube was torched to determine the composition in its wall

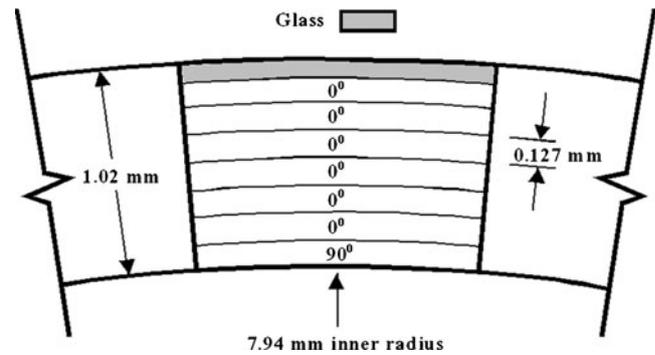
As shown in Fig. 5, there were seven 0.127 mm thick layers of carbon fiber and an outer layer of glass. The fibers in the six outermost carbon fiber layers were oriented at  $0^\circ$  with respect to the longitudinal axis of the tube while those in the innermost layer were oriented circumferentially (at  $90^\circ$ ). The tube used for the splice was similar in construction but the outermost glass layer as well as a portion of the underlying carbon fiber layer was removed so that the splice could fit within the outer tube.

**Fig. 5** The outer tube contained one transverse, six longitudinal, and one glass layer (dimensions in millimeters; angles denote fiber orientations with respect to longitudinal direction)

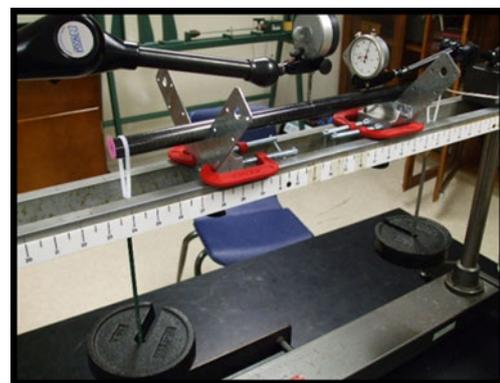
The structural performance of the outer tube was studied prior to constructing the tendons [18]. The photograph in Fig. 6, for example, shows the experimental set up used to measure the center deflection of a 0.305 m long section of the tube placed in pure bending.

In that experiment, the tube was simply supported and bent by applying loads at the ends of adjoining 89 mm long sections. Loads were varied over a limited range to check that the material properties listed in Table 1 and the composite lay-up determined from the diagnostic study were suitable for finite element modeling.

**Fig. 6** A continuous tendon is tested in four point bending

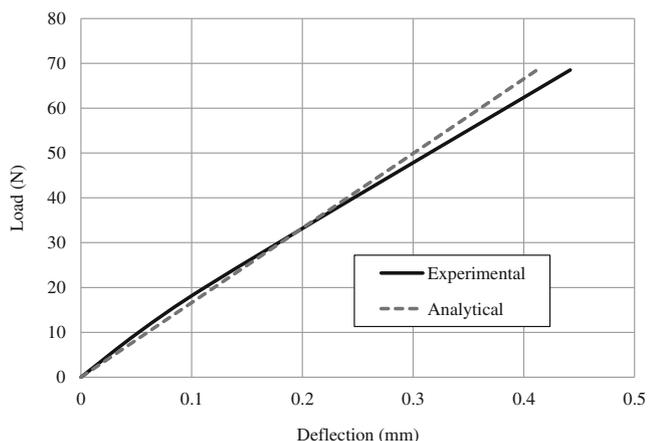
**Fig. 7** Load vs. deflection data for a 15.9 mm ID continuous tendon

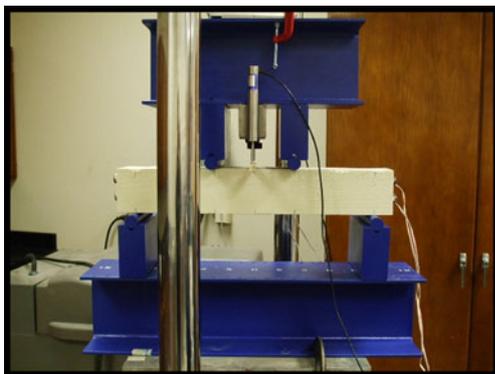
**Fig. 8** Reinforced concrete beam situated within test apparatus

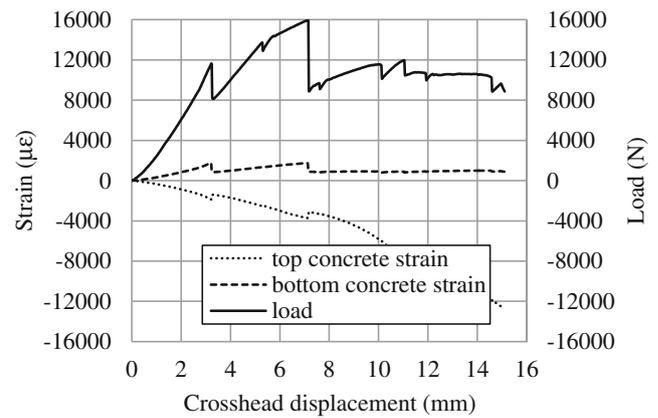
Referring to the plots shown in Figs. 9 and 10, immediately after the first crack occurred, the load dropped from 11.64 kN to 8.12 kN. The strain in the upper tendon decreased slightly from  $-1,074\mu\epsilon$  to  $-851\mu\epsilon$ , whereas that in

**Fig. 9** Concrete strain and load vs. crosshead displacement (beam 1)

Distinct shape changes can be seen in the strain plots when the first crack occurred. In the lower portion of the beam, the tensile strain on the bottom surface decreased (see Fig. 9) due to the crack and reduction in load. Despite the latter, the tensile strain in the lower tendon (see Fig. 10) increased. This is due to the stress transfer from the weakened concrete to the reinforcement and the upward shift in the centroid of the composite section.

The beam remained intact until the load reached 11.64 kN when the first crack occurred. The crack developed in the central span of the beam on the lower surface and, as illustrated in Fig. 11, was observed at a distance of 60.3 mm to the left of center. The event resulted in jump discontinuities which can be observed at a crosshead displacement of 3.22 mm in the load and strain plots for the surface mounted gages (Fig. 9) and the tendons (Fig. 10).

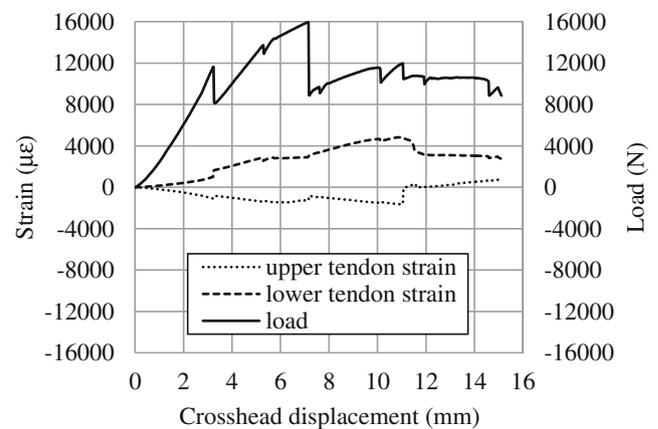
**Fig. 10** Tendon strain and load vs. crosshead displacement (beam 1)

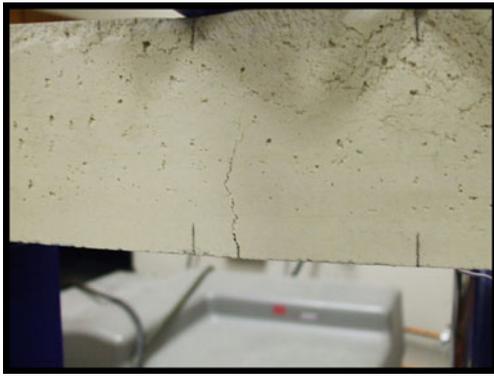
**Fig. 11** The materials remained elastic until the first crack occurred

Comparisons were also made regarding crack location. Referring to Fig. 15, the finite element model predicted that the maximum longitudinal strain in the concrete on the bottom of the central span was  $1,585\mu\epsilon$ . This occurred along the longitudinal centerline (half way across the width) at a distance of 57.2 mm to the right and left of center span. Close inspection of the spent beams indicated that cracks initiated at this location and subsequently propagated through the thickness until they appeared on the sides of the specimens at a distance of 60.3 mm from the center span (see Figs. 11 and 12). This was an exact match.

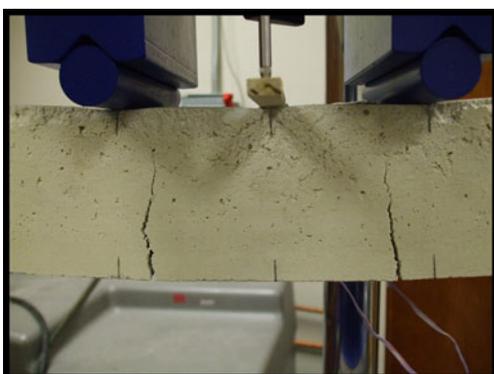
peak value of 15.94 kN, at which point a second crack was observed (see Fig. 12). This crack developed in the central span of the beam on the lower surface, and was observed at a distance of 60.3 mm to the right of center. The second crack extended up to the top of the upper tendon, and as time went on, propagated lengthwise toward the center of the beam.

**Fig. 12** After a sharp decrease in load occurred, the load increased until a second crack developed

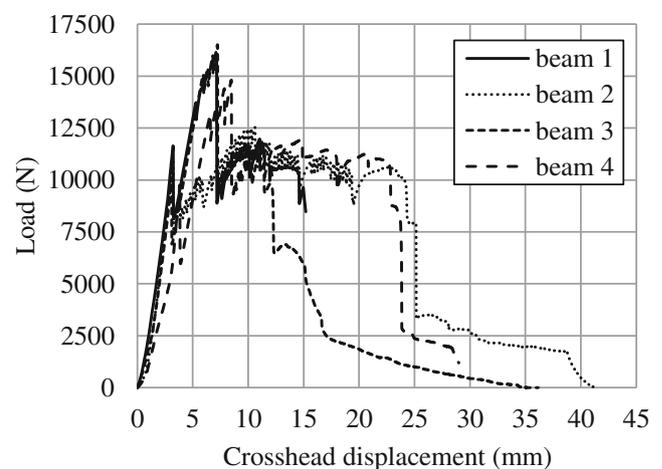
Figure 13 shows a superposition of load vs. deflection plots corresponding to the four beams tested. It is readily apparent that these curves provide a measure of structural integrity as well as valuable clues regarding how damage took place and progressed. A similar conclusion can be reached regarding the output from the strain gages.

**Fig. 13** Load vs. crosshead displacement of the four beams

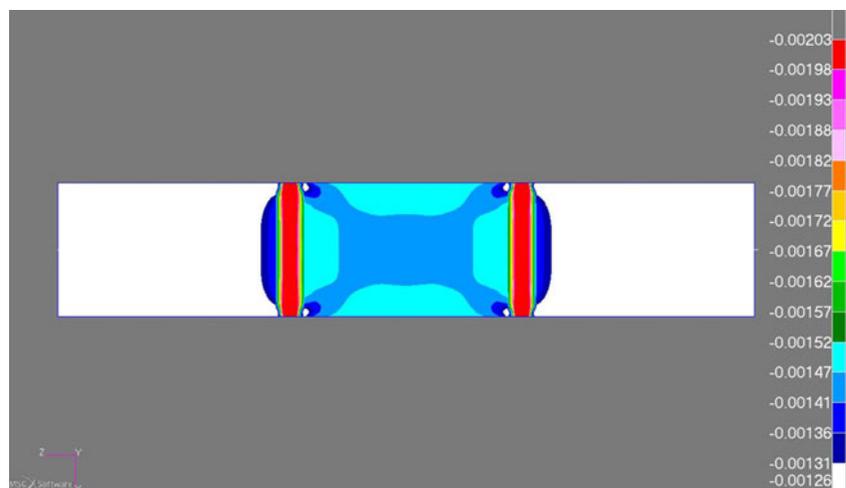
Figure 14, for example, shows a contour plot of the longitudinal, normal strain in the concrete on the top surface of the beam. In this case, the observer is looking directly

**Fig. 14** Longitudinal, normal strain in the concrete on the top surface of the beam

downward. The range for the strains was limited in this rendition to accentuate the strain gradient in the region located between the upper supports. The color key shown to the right in the figure corresponds to the strain level. The largest strain, occurs directly beneath the upper supports (see Fig. 2) due to the high contact stresses which occur there. The longitudinal, normal strain at the center of the span where the strain gage was located is  $-1,415\mu\epsilon$ . The latter corresponds to one of the three principal strains.

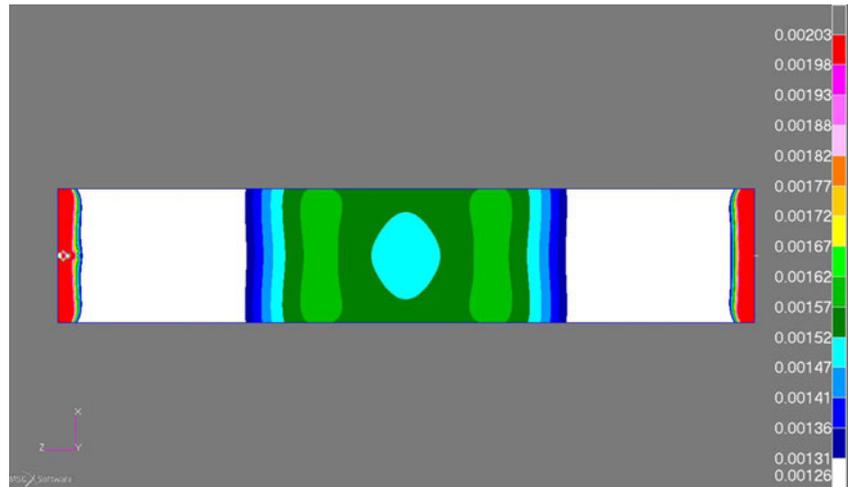
**Fig. 15** Longitudinal, normal strain in the concrete on the lower surface of the beam

A similar plot, tailored to show the strain gradient in the concrete located between the rollers on the bottom surface of the beam is shown in Fig. 15. However, in this case, the observer is looking directly upward. The range and color key are identical to those employed in Fig. 14 but the strains are of opposite sign. The largest strain, occurs directly above the lower supports (see Fig. 2) due to the high contact stresses which occur there. The longitudinal, normal strain at the center of the span where the strain gage was located is  $1,474\mu\epsilon$ . The latter corresponds to one of the three principal strains.

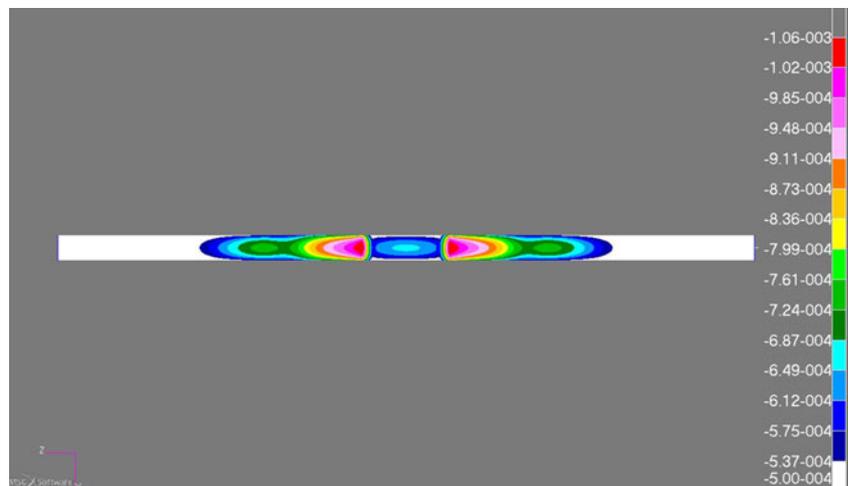
**Fig. 16** Longitudinal, normal strain on the top half of the inner surface of the upper tendon

Figure 16 shows a contour plot of the longitudinal, normal strains on the top half of the inner surface of the upper tendon. In this case, the observer is looking directly downward. The longitudinal, normal strain at the point on the free surface where the strain gage was located is  $-937\mu\epsilon$ . The latter corresponds to one of the principal strains. It should be noted, however, that the strains in the central portion of the figure where the splice is located are inter-laminar, since the layers of the splice lie directly below the innermost layer of the outer tube.

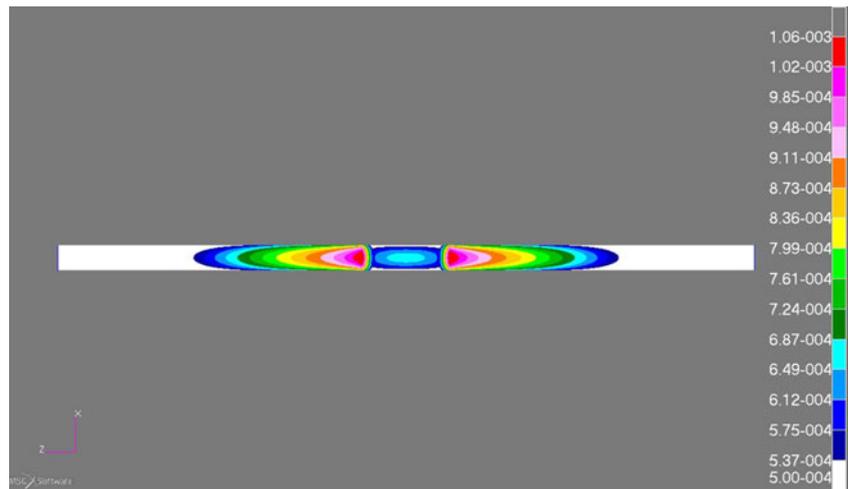
Figure 17, on the other hand, shows a contour plot of the longitudinal, normal strains on the bottom half of the inner surface of the lower tendon. However, in this case, the observer is looking directly upward. The range and color key are identical to those employed in Fig. 16 but the strains are of opposite sign. The longitudinal, normal strain at the point on the free surface where the strain gage was located is  $942\mu\epsilon$ . The latter corresponds to one of the principal strains. Again, the strains in the central portion of the figure where the splice is located are inter-laminar.

**Fig. 17** Longitudinal, normal strain on the bottom half of the inner surface of the lower tendon

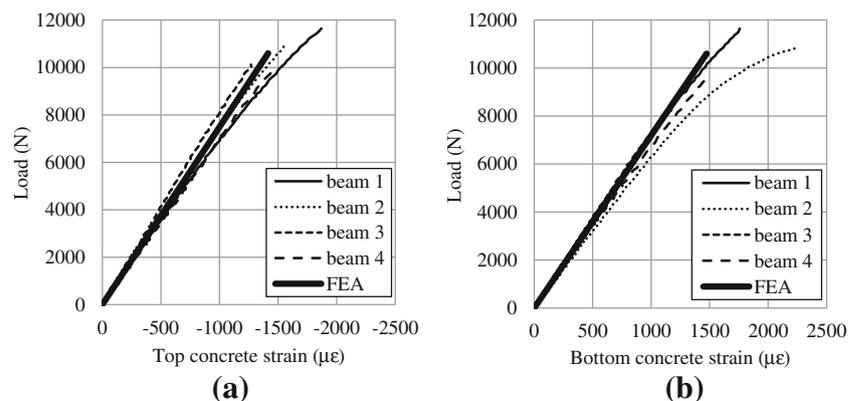
Figures 18(a) and (b), for example, show plots corresponding to load vs. strain data taken from the gages placed on the top and bottom concrete surfaces, respectively, of the four beams tested. The plots labeled FEA (finite element analysis) were generated by running the finite element program with the average load to failure.

**Fig. 18** Load vs. top concrete strain (a) and bottom concrete strain (b) in the four beams, to first crack

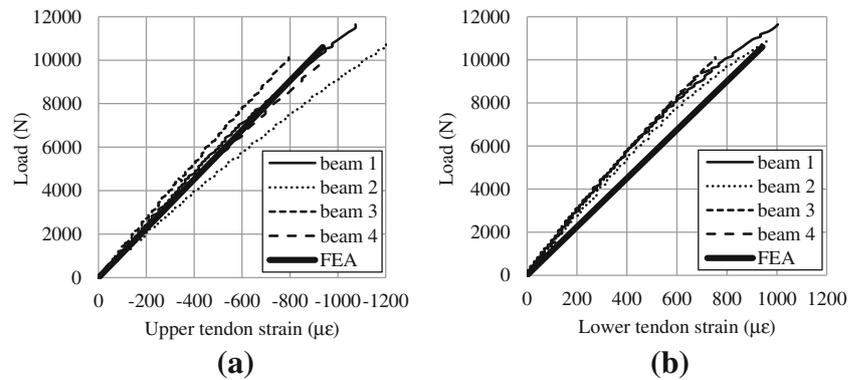
**Fig. 19** Load vs. upper tendon strain (a) and lower tendon strain (b) in the four beams, to first crack
