Uplift Capacity of Polyurea-Coated Light-Frame Rafter to Top Plate Connections

Abstract: This paper demonstrates the potential for using field-applied structural coatings to reinforce traditional framing members and standard building ties, thereby providing an improved and continuous foundation to roof load pathway. Tension tests were performed on light-frame rafter to top plate connections, some of which were reinforced with a hurricane tie, to establish how much of a difference a polyurea coating made as the joints between the stud and top plate, and top plate and rafter, were loaded to failure. The tests indicate that polyurea provides universal strengthening compared with hurricane ties with the added advantage that members and joints can be protected from a multitude of threats, including corrosion attributable to moisture, damage attributable to flood; and, with self-extinguishing properties fire. The addition of the coatings allowed both unreinforced and reinforced configurations to withstand higher loads (200–400% more). In general, the polyurea delayed the onset of failure and significantly strengthened every configuration by increasing the amount of work/energy required

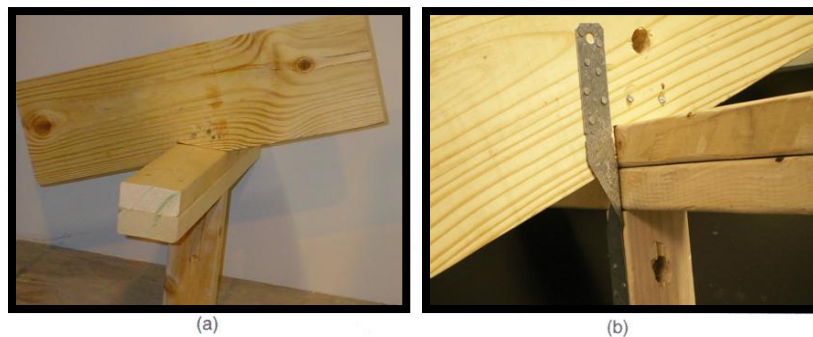
Fig. 1. Basic framing connection: (a) constructed; (b) reinforced with a hurricane tie

Standard nailed configurations, with and without the metal hurricane tie, were used to define control standards. While testing the configurations, the reinforcement effects caused by plywood sheathing that may be nailed to the top plate and the stud were neglected.

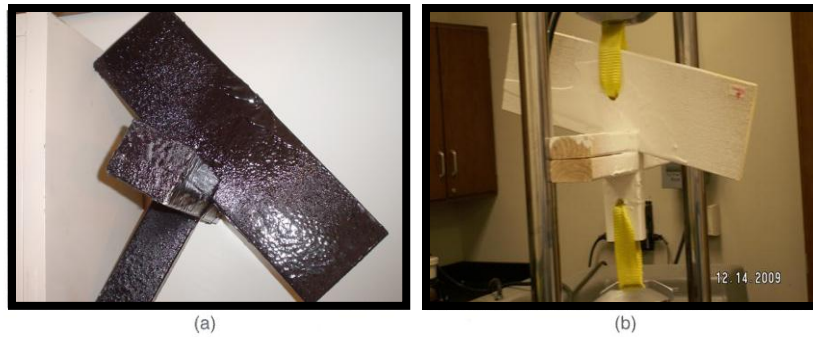
Fig. 2. Configurations coated with polyurea before subjecting them to uniaxial tension: (a) black; (b) white

As illustrated in Fig. 2, two different types of polyurea were employed: (1) a black version having a relatively large elongation (800%) and low elastic modulus (179 MPa), and (2) a white version having a relatively low elongation (200%) and high elastic modulus (483 MPa). The tensile strengths of the black and white polyureas were 16.0 and 15.2 MPa, respectively.

As illustrated in Fig. 2(b), the configurations were initially placed in uniaxial tension by passing Kevlar straps through two 2.34-cm-diameter holes drilled in the 2 by 4 and rafter. Each hole was reinforced using a 3.8-cm-long section of aluminum pipe. The 98-kN-capacity MTS testing machine used to conduct the tests was equipped with a load cell; and, comparisons and observations were made between uncoated and coated specimens that were pulled in deflection controlled tests at a rate of 1.27 cm/min.

Referring to the configuration shown in Fig. 2(b), each side of the upper and lower straps carries one-half of the total load. Hence, the total deflection in the pull straps is

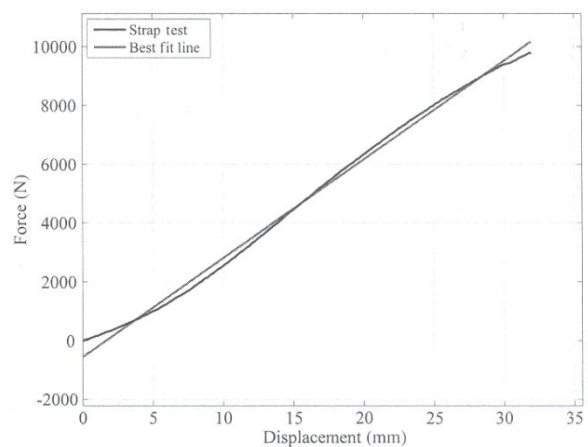
Fig. 3. Load versus deflection plot for a 50-cm-long Kevlar pull strap

A net deflection for each configuration was calculated by subtracting the deflection in the pull straps from that measured for the crossheads. The deflection in the pull straps was computed on the basis of Fig. 3, which shows a load deflection plot obtained by placing a 50cm long segment of one of the pull straps in tension.

A calibration factor, C , of $6 \mu\epsilon/\text{N}$ was obtained for the case when a 2.54-cm-long segment of the strap was subjected to a 4.45-N load by fitting a linear curve through the data in Fig. 3 over the load range observed during the test program (0 to 9790 N).

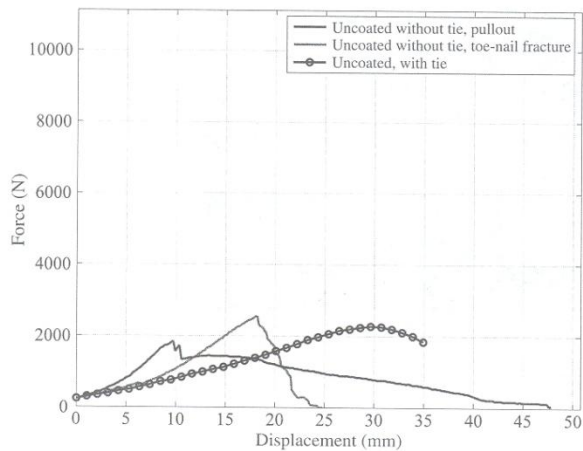
Fig. 4. Load versus deflection plots for uncoated specimens; see legend and Figs. 5 and 7 for details

Fig. 4 shows plots of load versus total deflection (of the configuration and the pull straps) corresponding to three uncoated specimens. Two of the configurations were unreinforced (without tie), whereas one was reinforced with a hurricane tie. The scale on the vertical axis was kept constant in all of the plots presented in this paper so that direct visual comparisons can be made.

Fig. 4 also includes a typical load versus deflection plot of an uncoated configuration that was reinforced with a Simpson LTS12 hurricane tie. As illustrated in Figs. (8a–b), failure occurred when the tie deformed as the nail farthest away from it pulled out of the stud. The specimen held a maximum load equal to 2277 N, which was considered “standard” for pullout failure of an uncoated, reinforced configuration.

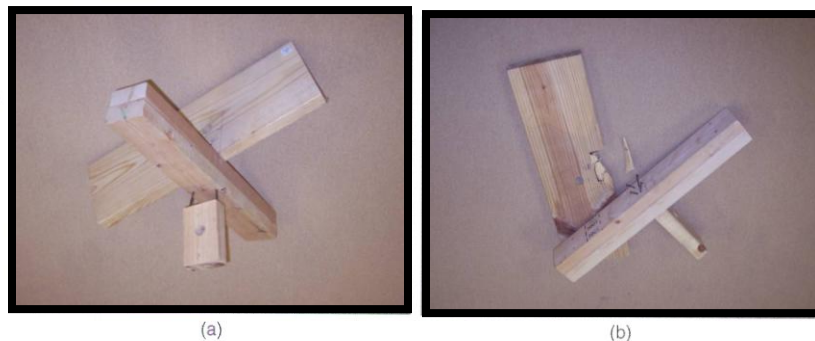
Fig. 5. Unreinforced configuration failure: (a) gradually as a result of 2 by 4 end nail failure; (b) abruptly as a result of toe-nail rafter failure

One of the uncoated configurations without the tie failed gradually as the nails in the top plate pulled out of the stud [see Fig. 5(a)]. This configuration, which held a maximum load equal to 1850 N, was considered the "standard" for 2 by 4 end nail failure; i.e., pull-out between the stud and top plate in an unreinforced configuration.

In contrast, the other uncoated configuration without the tie held a higher load (2562 N) and failed relatively quickly as the toe-nailed joint between the rafter and top plate fractured and gave way [see Fig. 5(b)]. This was considered a “best-case” scenario and the “standard” for toe-nail rafter failure, i.e., failure of the toe-nail joint between the top plate and rafter in an uncoated configuration.

Because nail pullout occurred in every other initial pull test except for this one, further analysis was conducted to understand why. Inspection of the lower joints in the specimens shown in Figs. (5a–b) revealed that all nails were driven vertically through the top plate into the stud. But Fig. 6 shows the grain structures in the studs. The ring patterns indicate that both studs were centrally cut; however, the relatively coarse grain structure observed in Fig. 6(a) resulted in end nail failure [see Fig. 5(a)], whereas the unusually fine grain structure observed in Fig. 6(b) resulted in toe-nail rafter failure [see Fig. 5(b)].

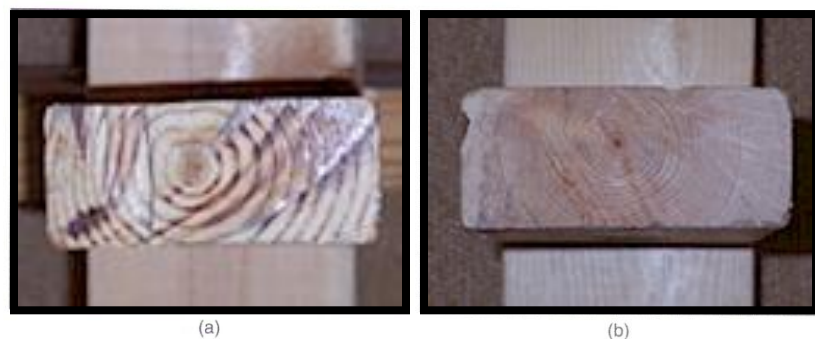
Fig. 6. Grain structure in the stud: (a) coarse and weaker; (b) fine

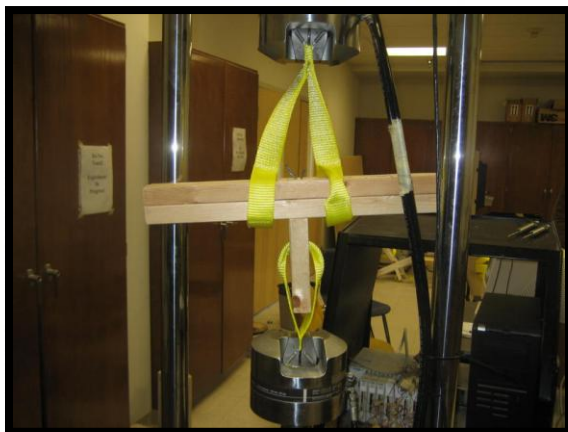
Fig. 7. Partial configuration shown in Fig. 5(b) retested for 2 by 4 end nail failure

The joint between the stud and top plate in the configuration shown in Fig. 5(b) was subsequently tested by placing pull straps over the top plate and through the hole in the stud (see Fig. 7). The partial configuration held 2998 N, substantially higher than the load applied to fail the toe-nail joint.

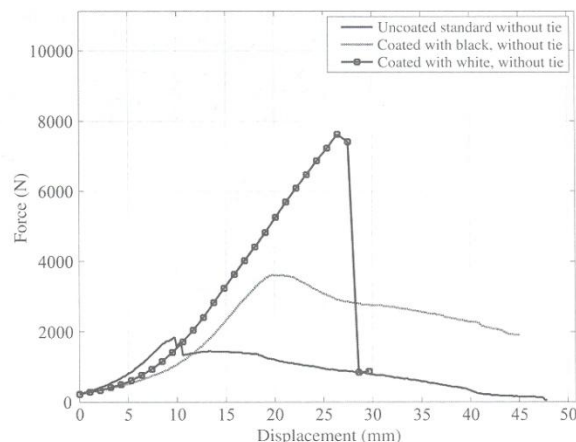
Fig. 9. Load versus deflection plots for 2 by 4 end nail failure in the uncoated unreinforced standard and coated unreinforced configurations

Fig. 9 shows the load/deflection plots obtained for the unreinforced standard along with those for typical unreinforced configurations coated with black and white polyurea.

The configuration that was coated with black polyurea held a maximum load of 3621 N and, as shown from the plot, failed

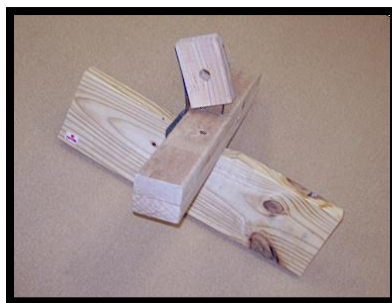
Fig. 8. Failure of reinforced configuration occurred when nail farthest from tie pulled out of stud

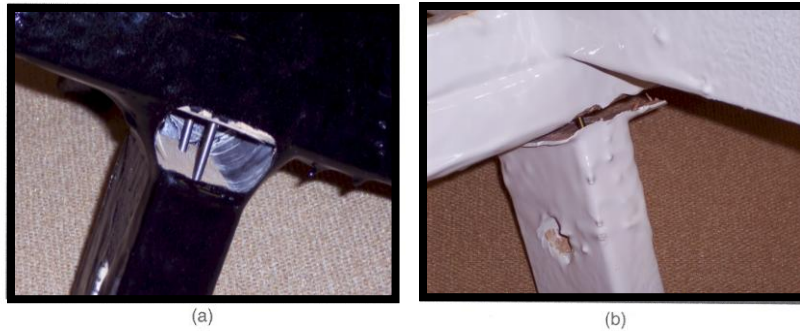
Fig. 10. 2 by 4 end nail failure: (a) occurred relatively slowly in black-coated, unreinforced configuration; (b) failed quickly in white-coated configuration after wood fibers fractured in top plate

relatively slowly. As shown in Fig. 10(a), a thin layer of wood fibers fractured in the top plate as the nails in the stud loosened and the coating stretched.

In contrast, the configuration coated with white polyurea held a maximum load of 7624 N and, as shown Fig. 10(b), abruptly failed when the wood fibers fractured in the top plate.

The superior bonding associated with the white polyurea was attributed to greater penetration into the wood substrate. A comparison of the specimens shown in Fig. 10 revealed that the fracture plane associated with the black polyurea [see Fig. 10(a)] is very close to the surface as opposed to that associated with the white polyurea, which lies deep within the wood grain [see Fig. 10(b)].

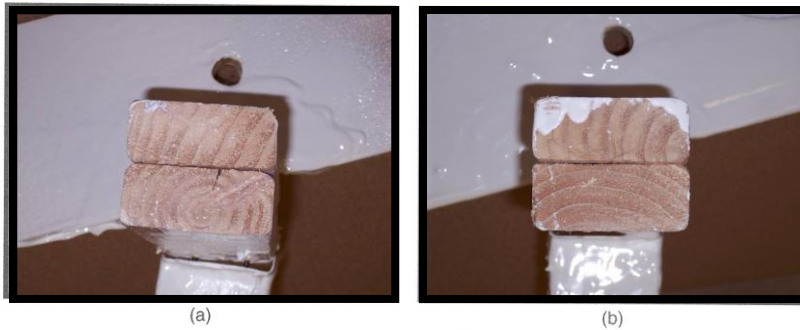
Fig. 11. Orientation of the grain in the lower member of the top plate: (a) weaker when oriented vertically; (b) oriented horizontally

An observation was made during a close inspection of the coated unreinforced configurations. Fig. 11 shows the grain structure in the top plates of two different unreinforced configurations

that were both coated with white polyurea. These configurations had very similar load/deflection plots, but the configuration in Fig. 11(a) held 7019 N, whereas the one in Fig. 11(b) [described previously and shown in Fig. 10(b)] held 7624 N. The difference is partially attributed to the orientation of the grain structure in the lower 2 by 4 that comprises the top plate. When the grain is oriented vertically [see Fig. 11(a)] parallel to the nail surface, the joint is relatively weak as compared with when the grain is oriented horizontally [see Fig. 11(b)] perpendicular to the nail surface.

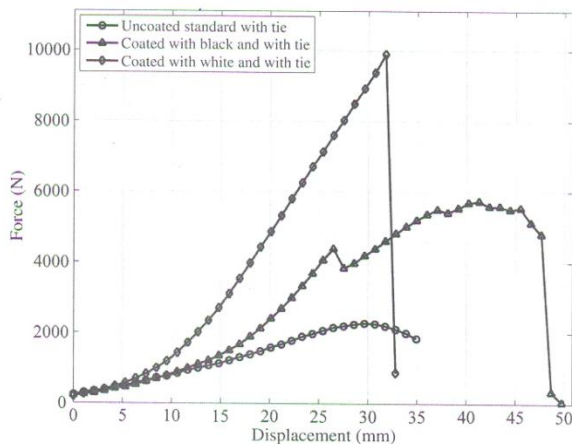
Fig. 12. Load versus deflection plots for 2 by 4 end nail failure in the uncoated reinforced standard and coated reinforced configurations

Fig. 12 shows the load/deflection plot obtained for the reinforced standard along with those for typical reinforced configurations coated with black and white polyurea.

It is clear by looking at the slopes of the plots shown in Fig. 12 that the coatings stiffen the configuration, the white much more so than the black. Although the white-coated configuration holds more load, the black-coated configuration is able to sustain more deformation.

The secondary peak observed at a deflection of approximately 2.54 cm in the curve associated with the black-coated configuration was seen in every test conducted on configurations of this type. The peak may correspond to the fracture that takes place in the wood and, if so, could provide some insight into the relative bond strength associated with the two polyurea coatings. Assuming that the wood fibers fracture in the white-coated configuration at failure, the bond strength associated with the white coating is more than twice of that associated with the black.

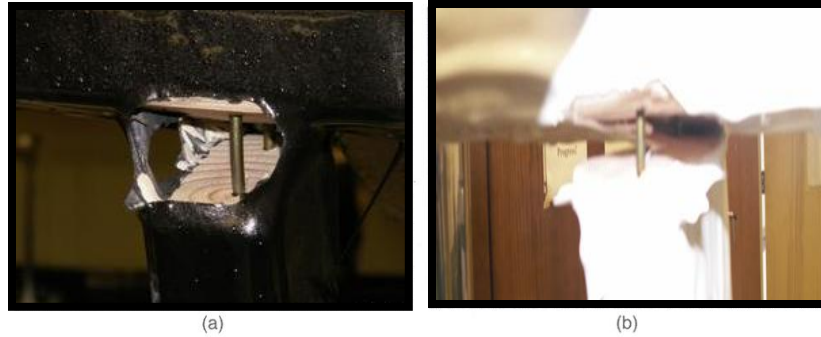
Fig. 13. Coated reinforced configurations failure when wood fibers fractured in top plate: (a) relatively slowly; (b) quickly

The configuration that was coated with black polyurea held a maximum load of 5738 N. As illustrated in Fig. 13(a), the wood fibers, diametrically opposed to the hurricane tie and along the sides of the stud, fractured in the lower member of the top plate. Then while the coating stretched, the nails in the stud loosened.

In contrast, the sample coated with white polyurea held a maximum load of 9906 N. As illustrated in Fig. 13(b), the configuration abruptly failed when the wood fibers, diametrically opposed to the hurricane tie and along the sides of the stud, fractured in the lower member of the top plate.

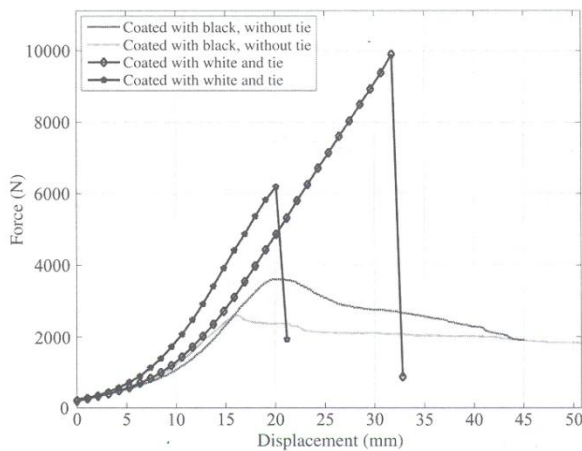
Fig. 14. Load versus deflection plots for 2 by 4 end nail failure in similar specimens that withstood very different peak loads

During the initial pull test program, two coated configurations held substantially lower loads than those reported previously: (1) an unreinforced configuration coated with black polyurea, and (2) a reinforced configuration coated with white polyurea. The load/deflection curves obtained for these cases are plotted in Fig. 14 along with those corresponding to their stronger counterparts.

Inspection of these weaker specimens revealed that the polyurea felt sticky and failure occurred in the polyurea itself as opposed to within the wood fibers. This problem was attributed to incomplete mixing, which most likely occurred when one of the canisters in the spray gun ran dry before the other. Although the peak load is very different for the weak and strong specimens, for a given polyurea, the shapes of the curves are similar.

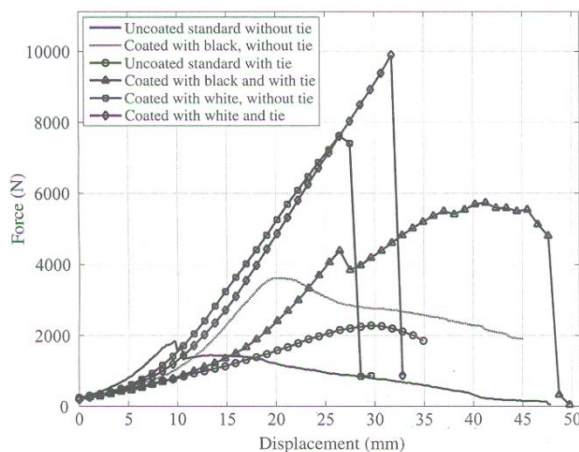
Fig. 15. Load versus deflection plots for 2 by 4 end nail failure in six different configurations

Fig. 15 includes load/deflection plots corresponding to pullout for all six cases tested: (1) an unreinforced configuration,

(2) a configuration reinforced with a hurricane tie, (3) an unreinforced configuration coated with black polyurea, (4) an unreinforced configuration coated with white polyurea, (5) a reinforced configuration coated with black polyurea, and (6) a reinforced configuration coated with white polyurea.

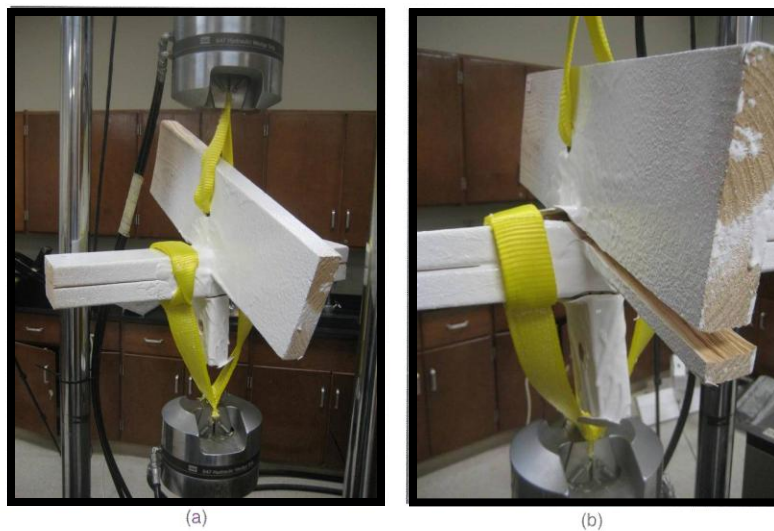
**Fig. 16.** Partial coated configurations retested: (a) to evaluate toe-nail after failure; (b) a crack developed in the rafter

As noted previously, all specimens except for one failed as the nails in the top plate pulled out of the stud. As illustrated in Fig. 16(a), the other partial configurations that did not include a hurricane tie were tested by placing pull straps over the top plate and through the hole in the rafter. Fig. 16(b) shows how the toe-nail joint failed in the coated specimens as a crack developed and propagated along the rafter. This was notably different from the failure that occurred in the standard [described previously and shown in Fig 5(b)] in which the wood surrounding the nails fractured.

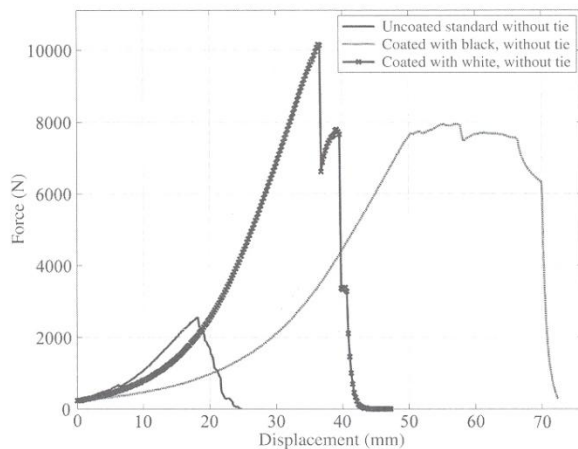
Fig. 17. Load versus deflection plots for toe-nail rafter failure of the uncoated unreinforced standard and unreinforced configurations coated with black and white polyurea

Fig. 17 shows plots of load versus total deflection (of the configuration and the pull straps) corresponding to toe-nail fracture for an uncoated standard and configurations coated with black and white polyurea.
